ANNEX G

Technical relation – Confiscated Asset in Elbasan

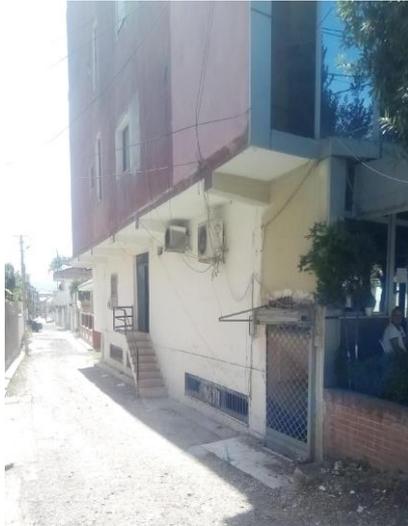
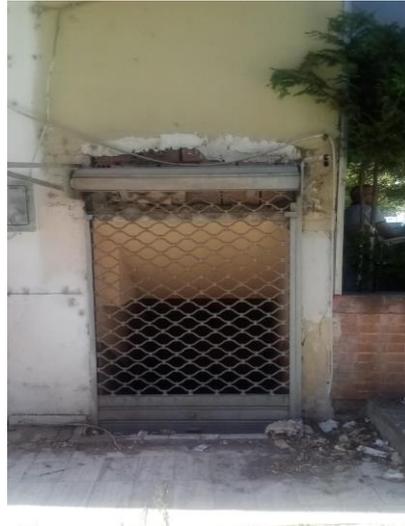
The asset is located in the cadastral area 8524, property number 4/216-B, with a surface of 85 m². The entrance is at the beginning of a secondary road, perpendicular to the main street. This is the only access point to the property because it is a basement space. It is linked with the street level through a staircase. In addition to the entrance, the other two natural light points are two ribbon windows that are located along all the perimeter, three on one side, and another one on the backside. The asset consists of a rectangular room and a service area (ante-bathroom and bathroom).

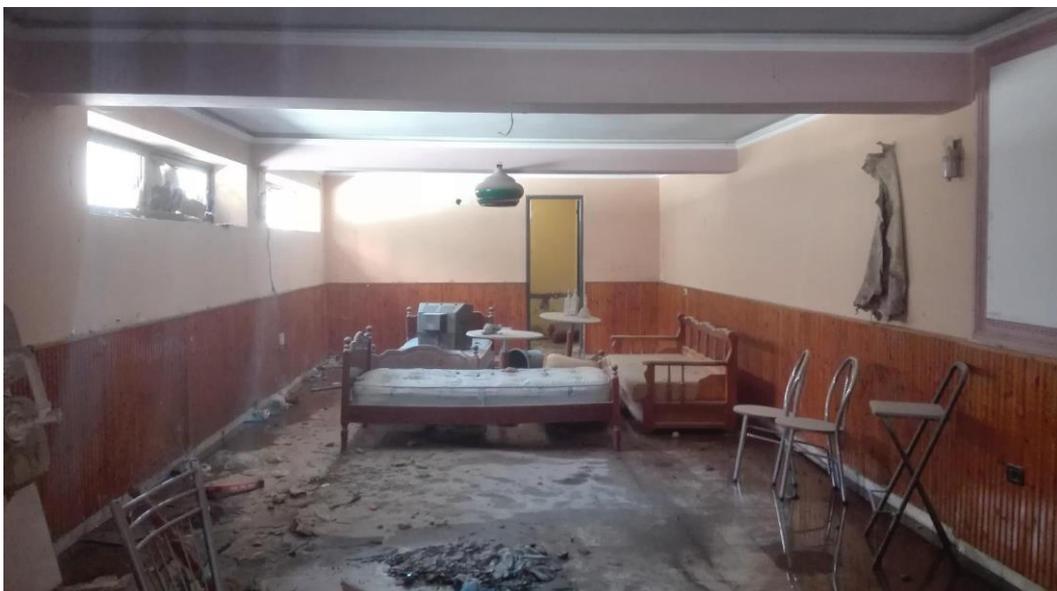
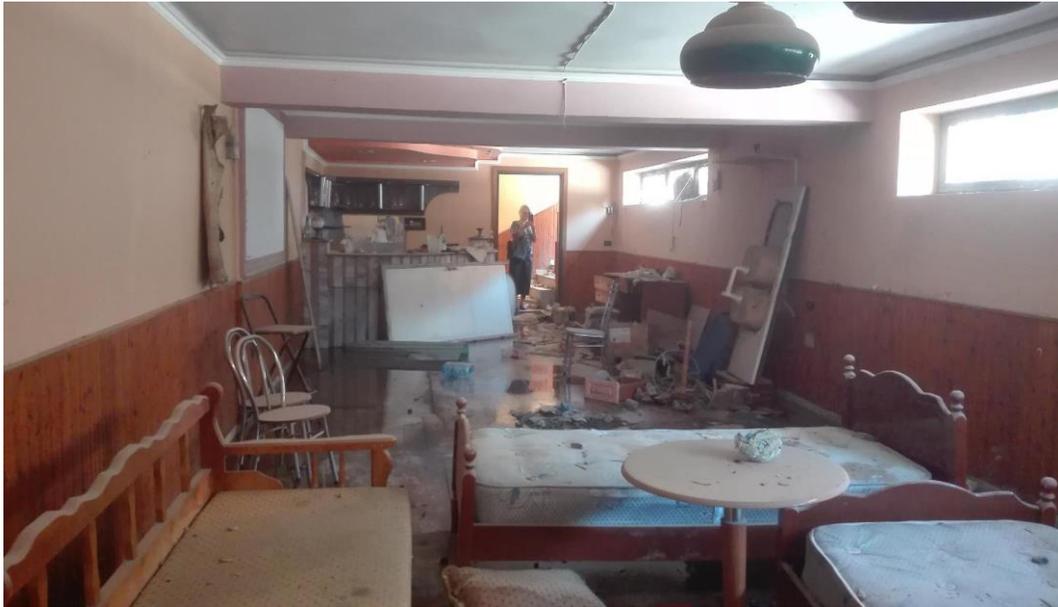
Actual state of the Asset

The actual state of the asset is generally good, even if cluttered with various materials and rubbish. There is water on the floor, but it does not seem that there are infiltrations. Probably the water comes from the exterior, because of the absence of windows fixtures.

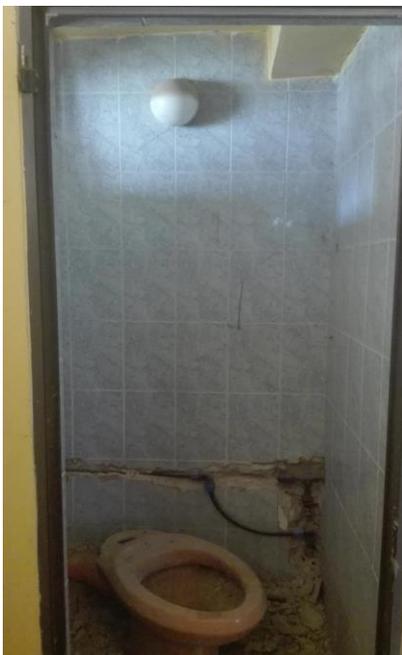
Visually, the system seems to be recently installed and in good condition. There is no conditioning system. In the bathroom, there is a toilet bowl, so there are connections for the water system.

Despite the water on the floor, visually there is no infiltration and there is no infiltration from the ceiling. All along the perimeter, there is wood panelling, not particularly damaged. This installation does not allow us to fully investigate the potential rising of water.
